# Manhole Inspection Summary

Manhole # S31AA\_021MH

Insp Date: **3/18/08 11:03 AM**

**Location** Address: **507 DRUID HILL AVE**

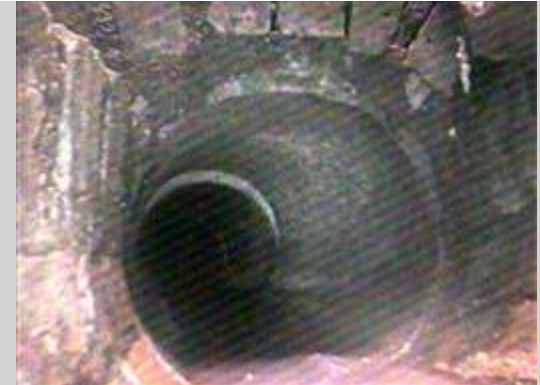
12 O'Clock Outflow

10 in. Circular Gravity Sewer  
Pipe Out @ 12 O'Clock

Pipe Height: (in.) Direct  
Pipe Material: **Clay** ☐ Pipe Lined  
Invert Depth: **9.32** (ft.) Flow Characteristics: **Slow**  
Deposits: ☒ None ☐ Mud ☐ Sludge ☐ Debris ☐ Grease  
Silt Depth: (in.) Deposits Extent:  
Infiltration: **None** Pipe Seal Cond: **Sound**

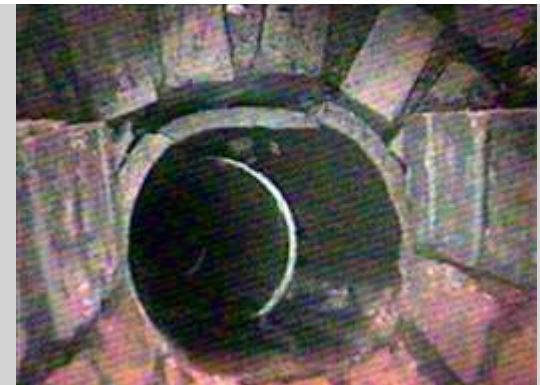
3 O'Clock Inflow

8 in. Circular Gravity Sewer  
Pipe In @ 3 O'Clock

Pipe Height: (in.) Direct  
Pipe Material: **Clay** ☐ Pipe Lined  
Invert Depth: **8.87** (ft.) Flow Characteristics: **Slow**  
Deposits: ☒ None ☐ Mud ☐ Sludge ☐ Debris ☐ Grease  
Silt Depth: (in.) Deposits Extent:  
Infiltration: **None** Pipe Seal Cond: **Broken**

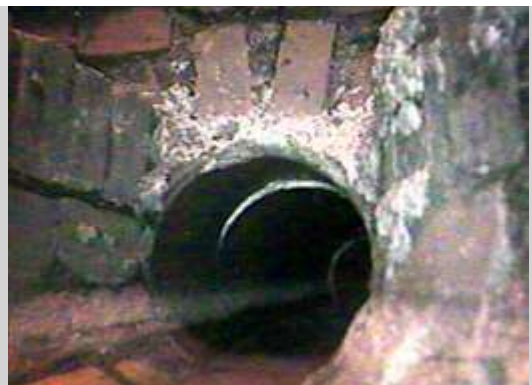
9 O'Clock Inflow

8 in. Circular Gravity Sewer

Pipe In @ 9 O'Clock

Infiltration: **Evidence** Pipe Seal Cond: **Sound**
